Golden Sands Hollow Core and  
Prestressed Beam/Column  
Construction

# Golden Sands Condominium

**Multiple Waterproofing Repair**

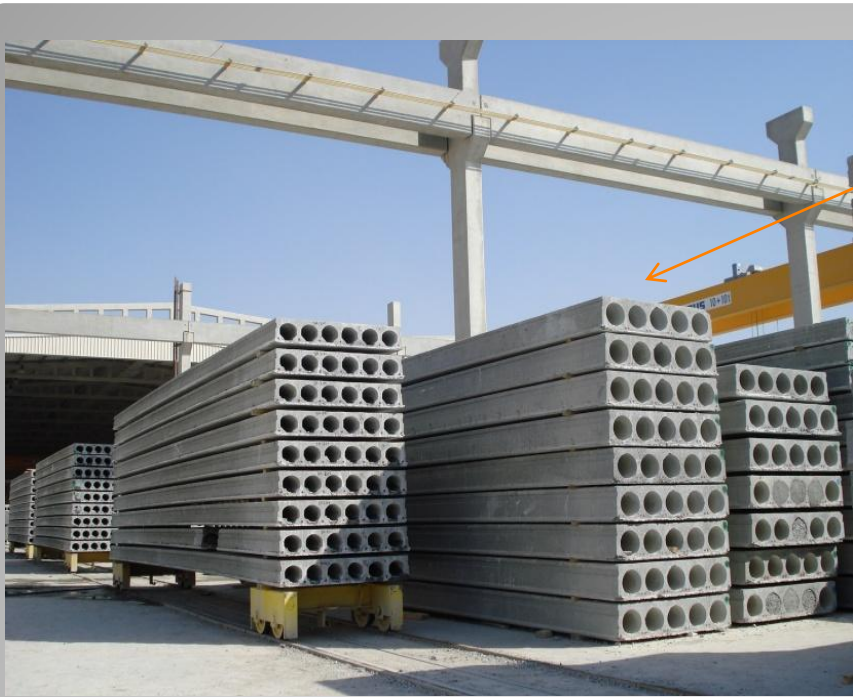
Plank = 8' x 26' +/-  
Plank Reinforcing 7 Strand -  
Prestressed Wire  
Embedded weld plate  
Formed edge key for grouting  
Planks have a concave slope end to  
end

Grout Key

Embedded weld plates

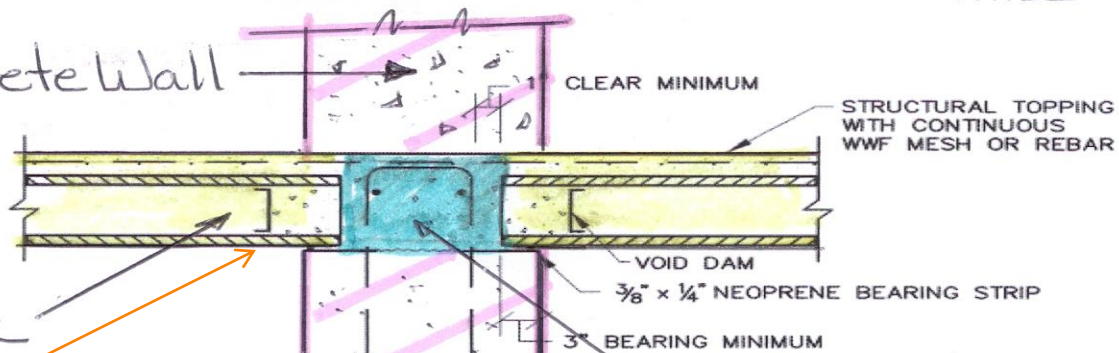
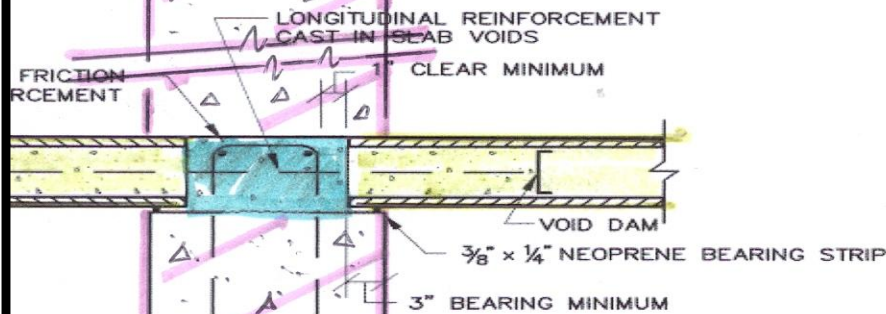
PROBLEM:

Plank bearing length on concrete wall varies 1" → 4"

At Exposed  
Balcony: Hinging  
@ Hollow Core  
Plank w/Balcony  
Slab Cracking  
and **Water  
Infiltration**

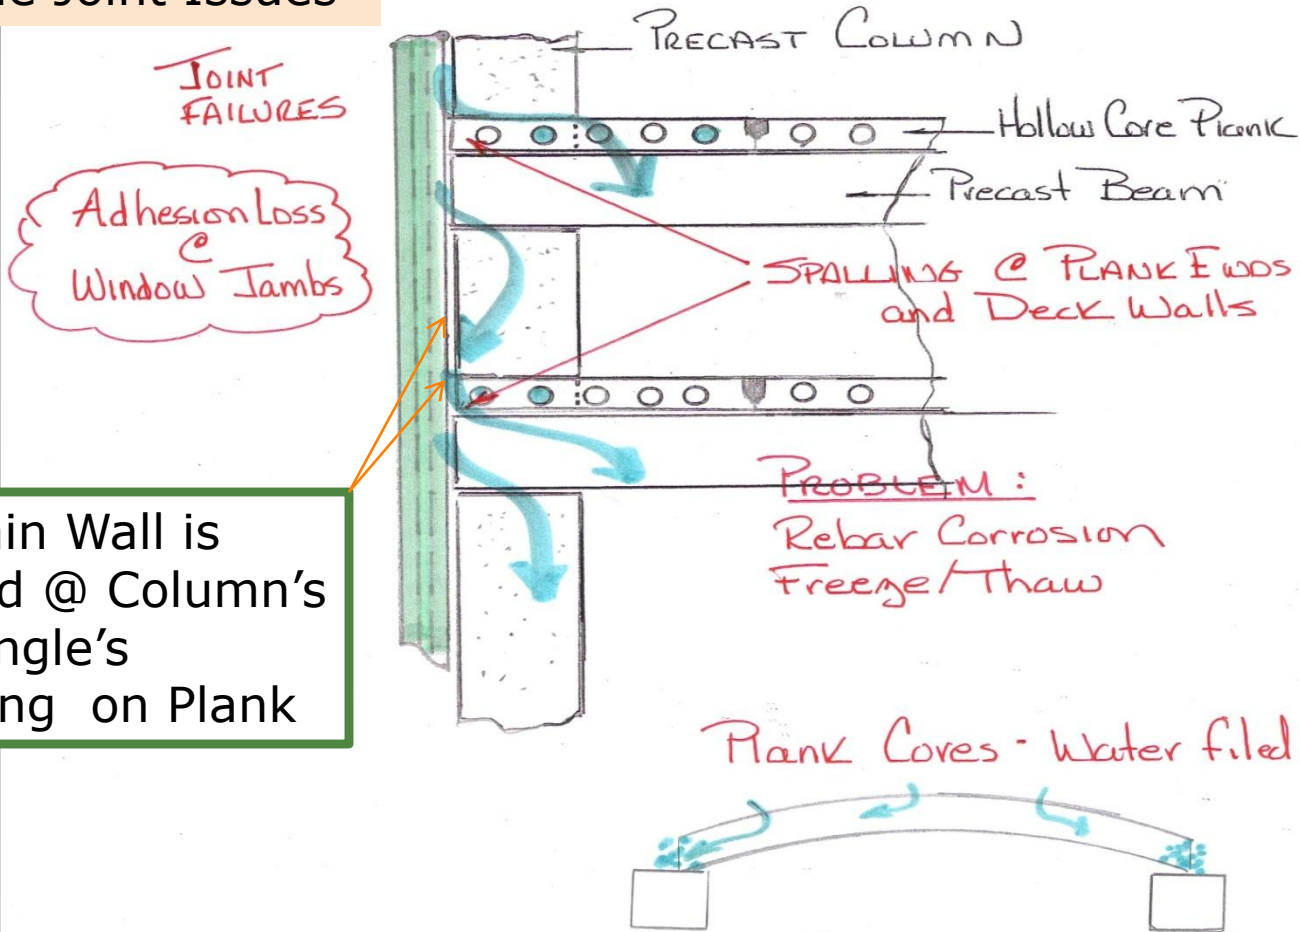
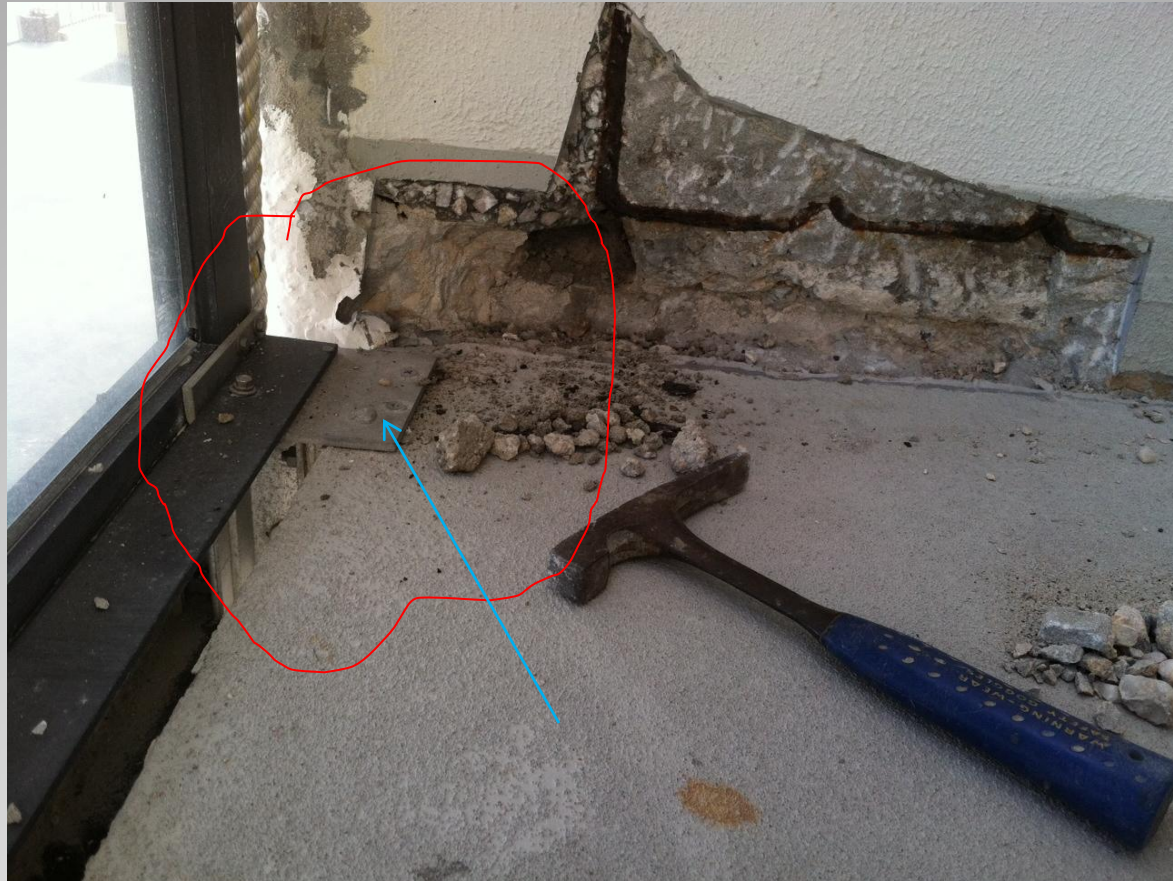
# Balcony Floor Bearing Plate

# TYPICAL WATER INFILTRATION

## Multiple Joint Issues

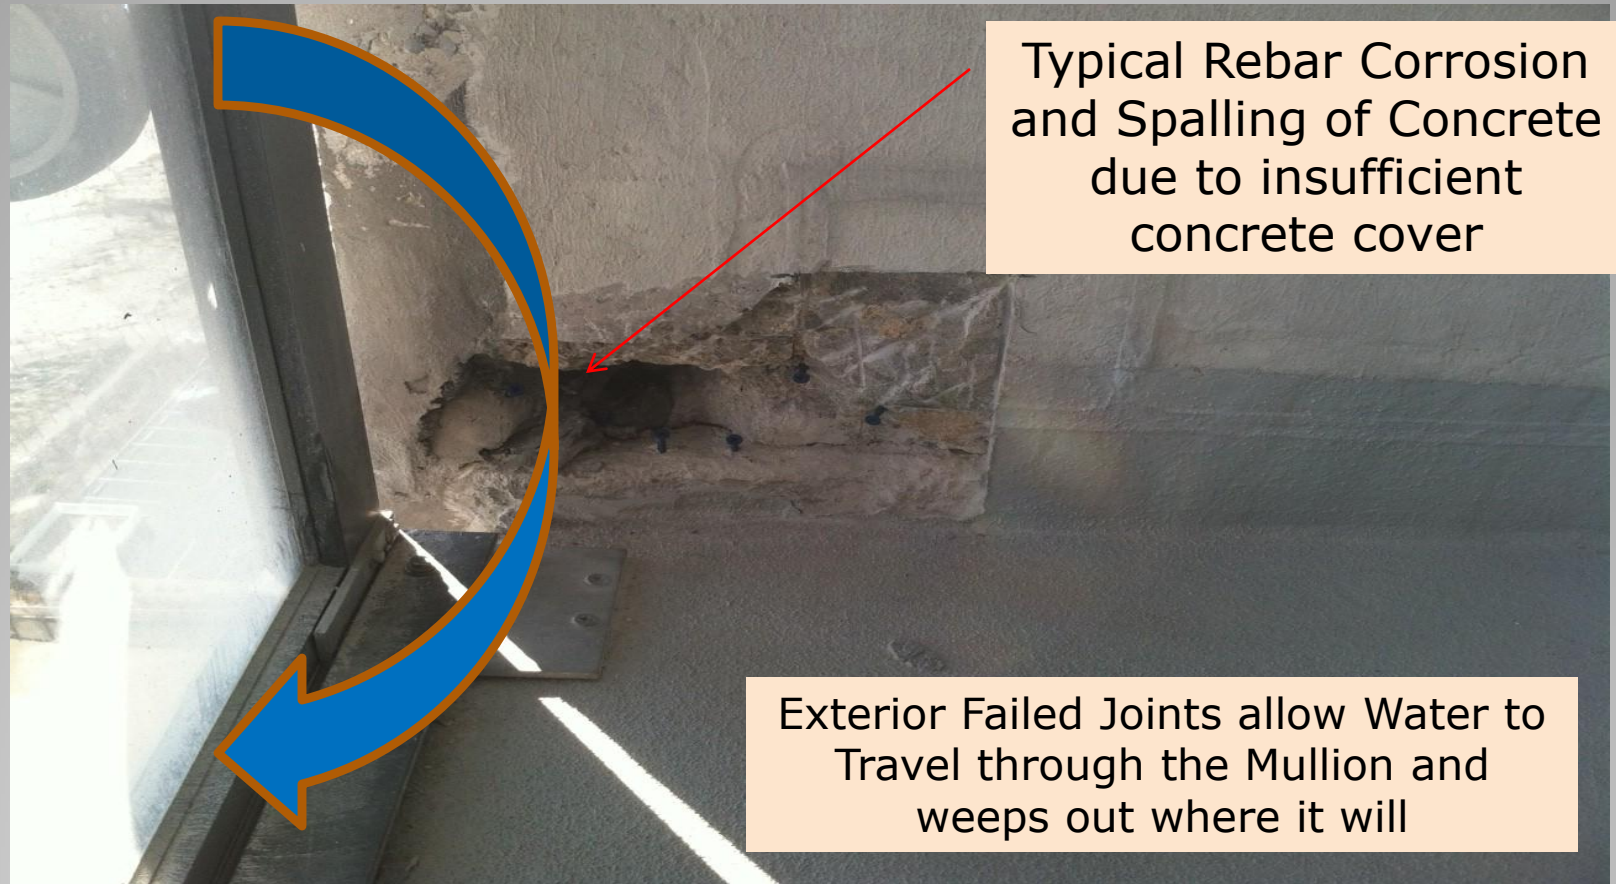
# Corrosion of Reinforcing Steel and Spalling Concrete

Typical Rebar Corrosion and Spalling of Concrete due to insufficient concrete cover

Exterior Failed Joints allow Water to Travel through the Mullion and weeps out where it will

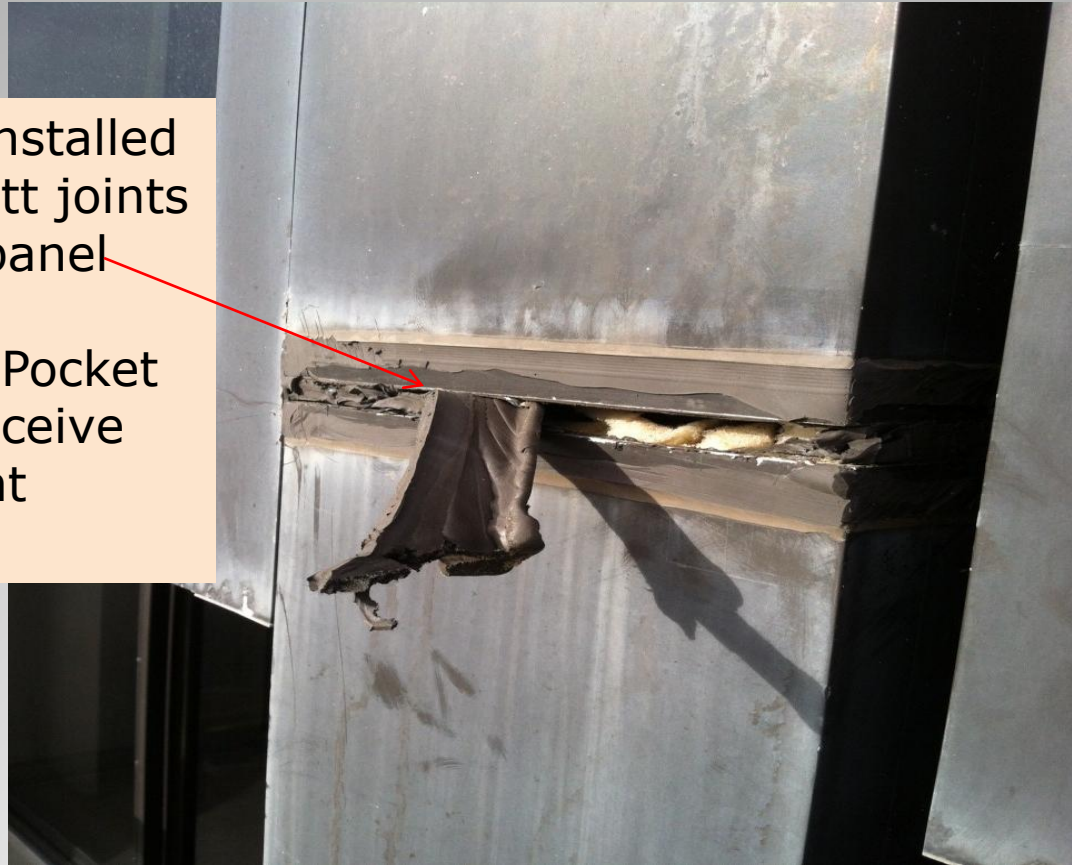
## Cover Plate @ Columns

Existing Condition:

The sealant was packed in the joint throat...

4-6" deep... Restricting movement between the balcony handrail and column .

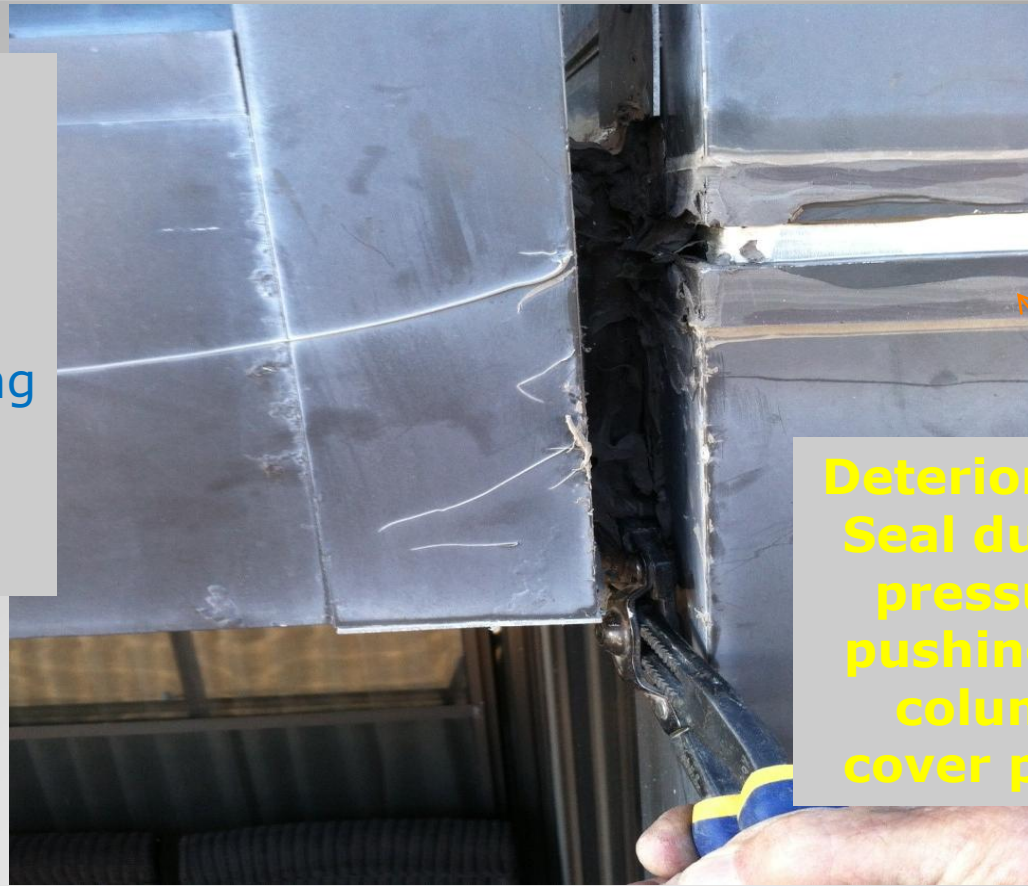
## Balcony Handrail @ Column Intersection

**Deteriorated Seal due to pressure pushing on column cover plate**

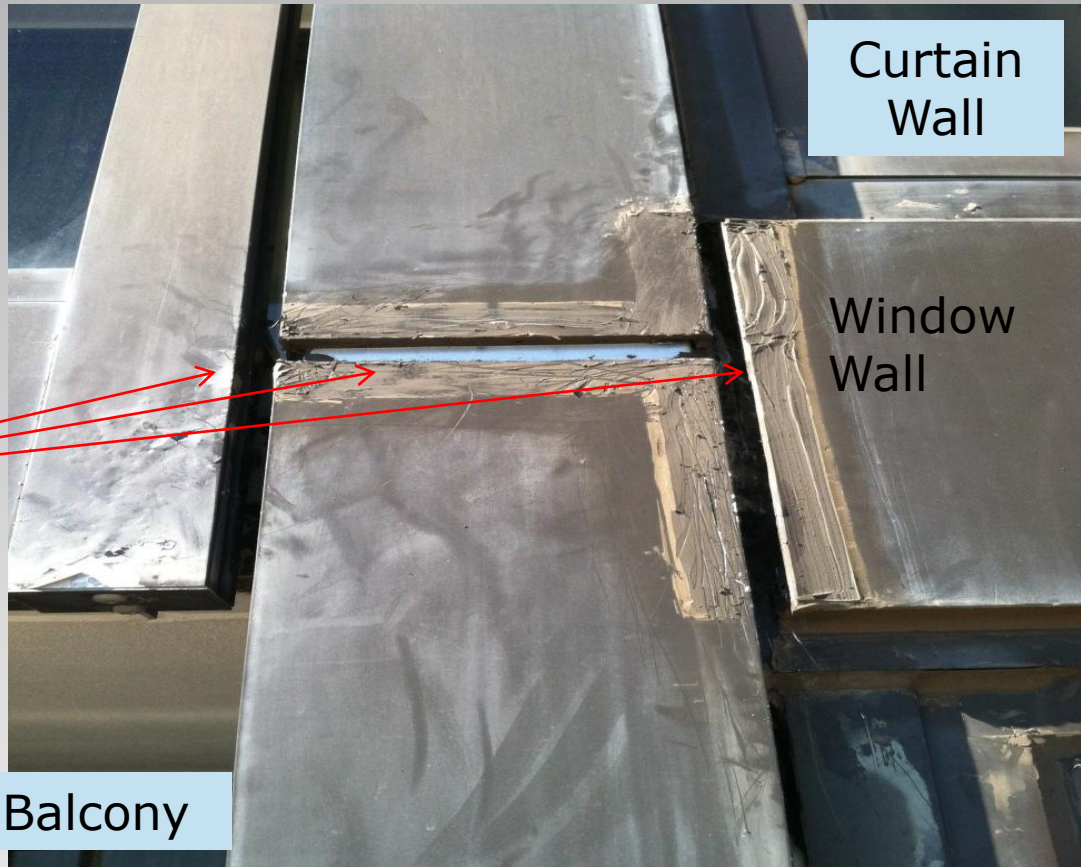
# Typical Sealant Removal

Floor Plank and  
Column  
Intersection w/  
Existing Caulk  
cut out of Joint  
Throat

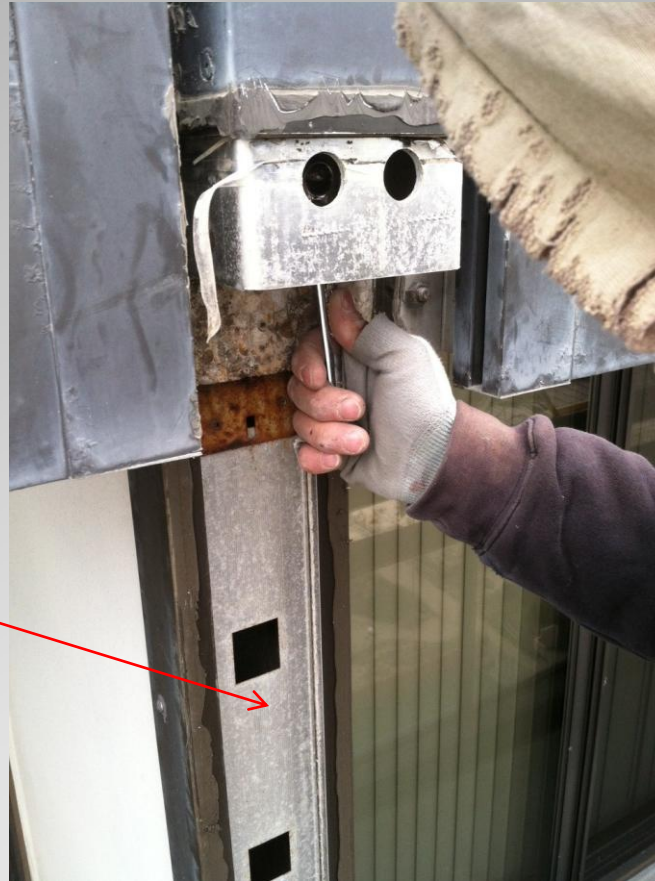
Unbolting bracket  
at Party  
Wall...Center of  
hollow core  
plank...non-load  
bearing interior  
wall

Note: Openings in  
Steel Stud and  
Mullion were  
closed & coated  
with a Rubber  
Membrane...(No  
allowances were  
made for frame  
drainage)

**Party Wall...center of plank**

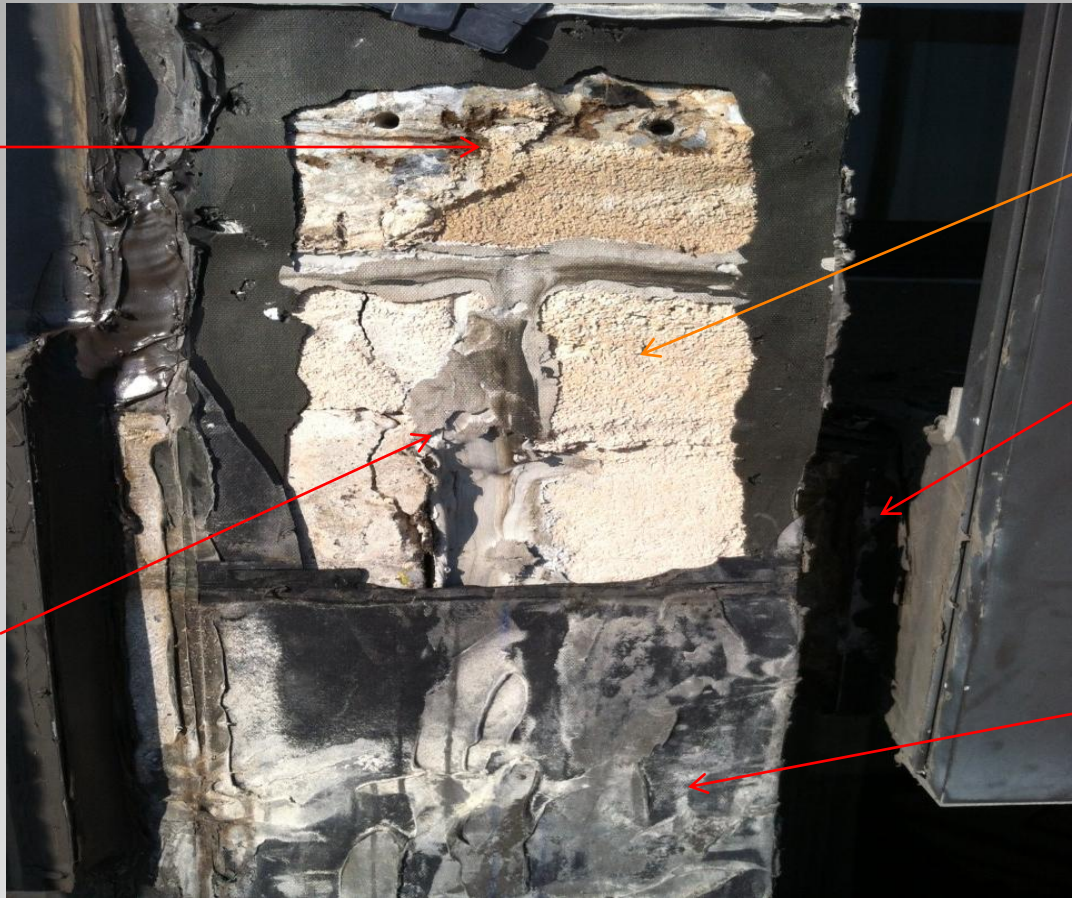
## Exposed Intersection of Hollow Core Plank and Prestressed Beam

Sounding:  
Hollow  
Thud

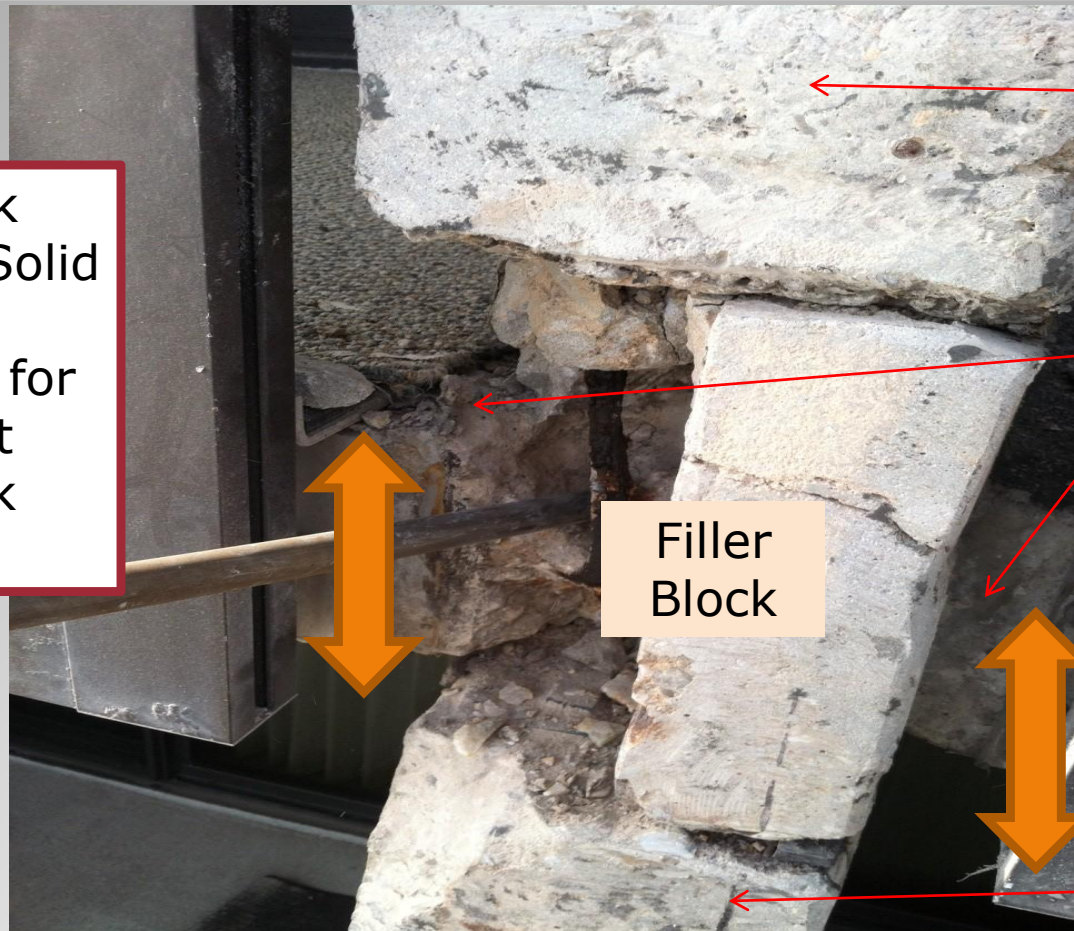
## Cracked and Spalled Filler Block

Filler Block  
Installed Solid  
with...No  
allowance for  
movement  
from plank  
hinging

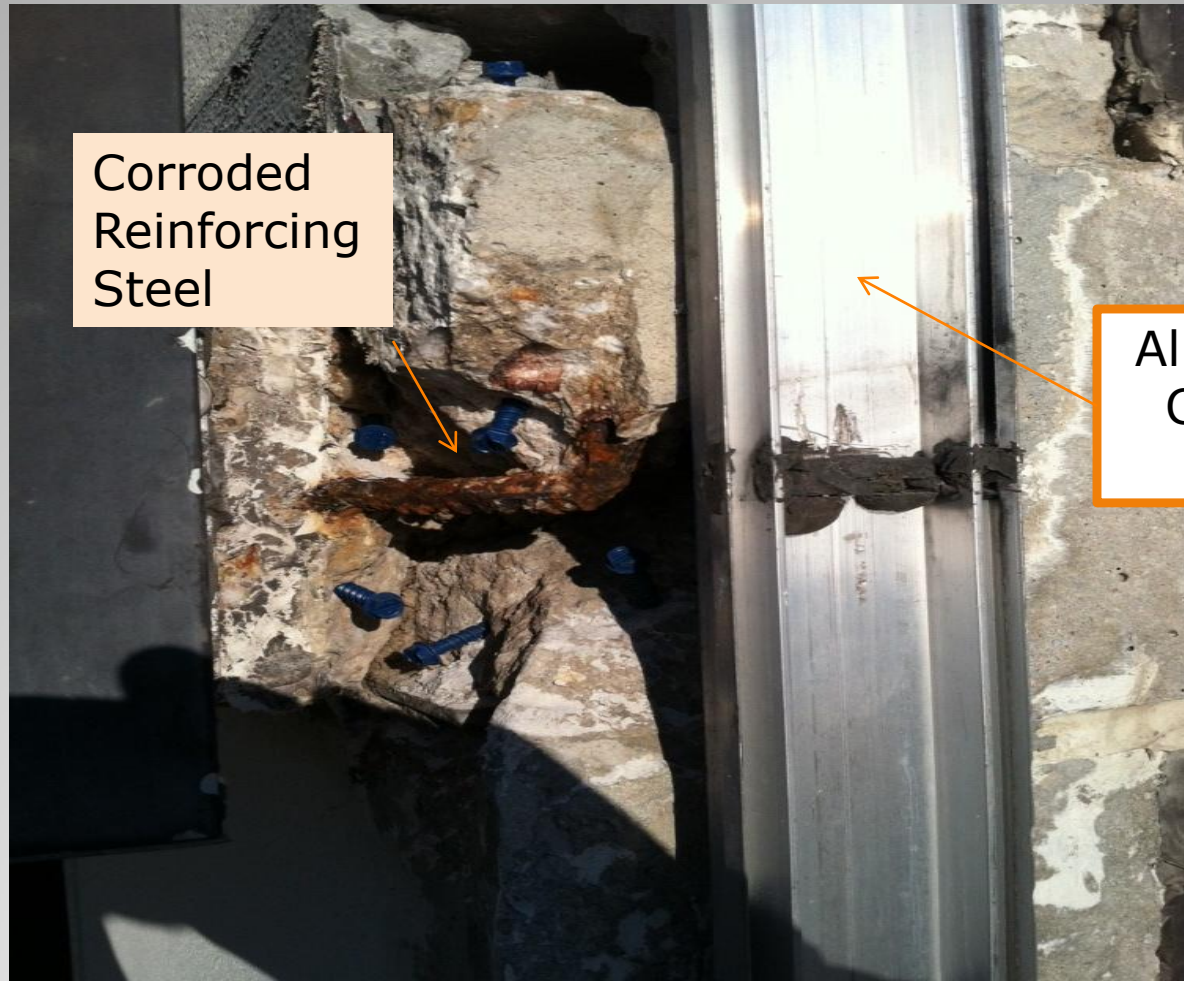
# Corroded Steel

Corroded  
Reinforcing  
Steel
